**REQUEST FOR PROPOSAL  
MV 2025-16  
ENGINEERED DESIGN OF CROOKED SLIDE PARK CHUTE AND WALKWAY**

**APPENDIX B – Structural Review: Crooked Slide Park, Combermere**

**Structural Review: Crooked Slide Park, Combermere.**

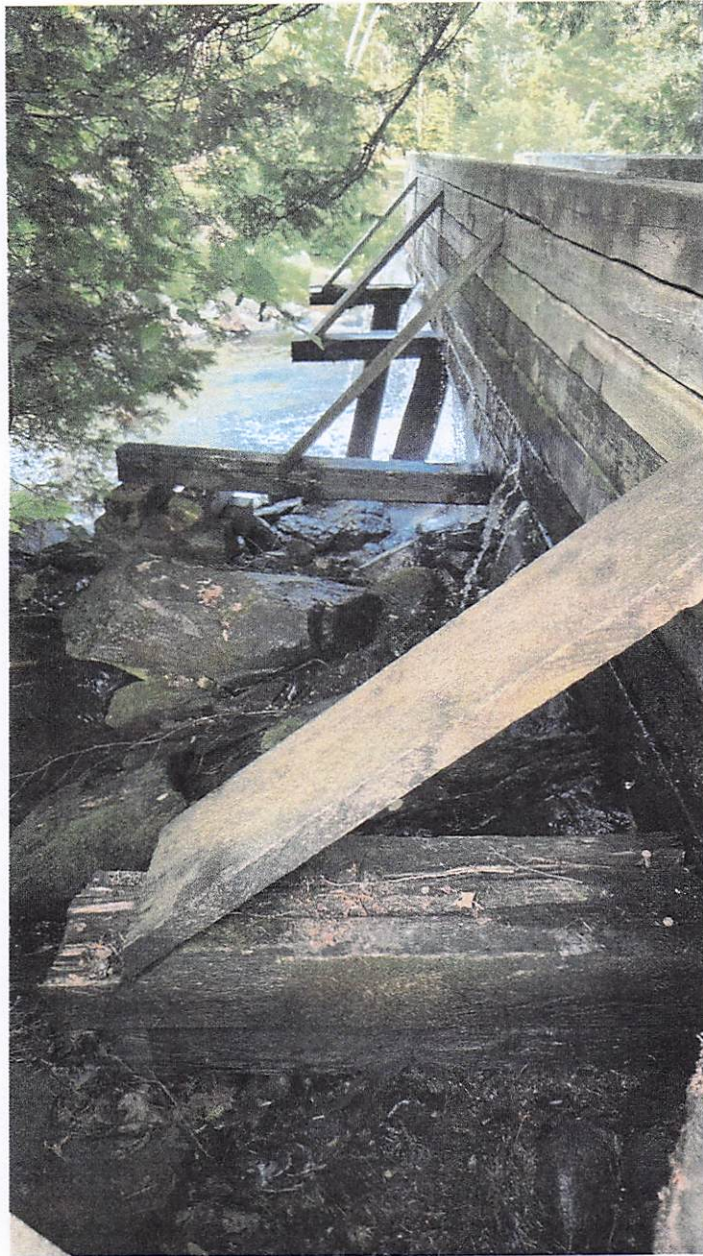
This section of the log chute, running for 34 feet, shows the greatest signs of deterioration in the entire structure and should be considered a priority for remedial action. All supporting elements are showing signs of excessive rot and decay and connections between posts, beams, and braces have deteriorated significantly. In each supporting component, there is a great amount of cracking, rotting, and voiding caused by decay. Aside from the diagonal braces, these wooden elements are quickly losing their ability to provide the required support to the chute assembly. On the one section of supporting assembly that has been more recently repaired/replaced, the beam used is heavily deflected, suggesting it is undersized for the loads present (see photo #1).

**Photo #1: Lower Elevated Chute Post and Beam Supports**

This section presents the most significant deterioration and it is strongly recommended that repairs/replacement be undertaken within the next 2 years. While some material remains viable for re-use (namely 6" x 6" timbers), most structural members will need complete replacement. It is estimated that no more than 25% of the 6" x 6" timbers will be fit for re-use. Should their re-use be considered, it is advised to re-install them as the top courses of timbers only, so as to facilitate easier future replacement. All posts and beams will need full replacement, including re-anchoring the posts to their bedrock base. Use of a species suitable for continual water exposure, or pressure treated wood strongly recommended. All replacement materials should be sized the same as the elements they replace.

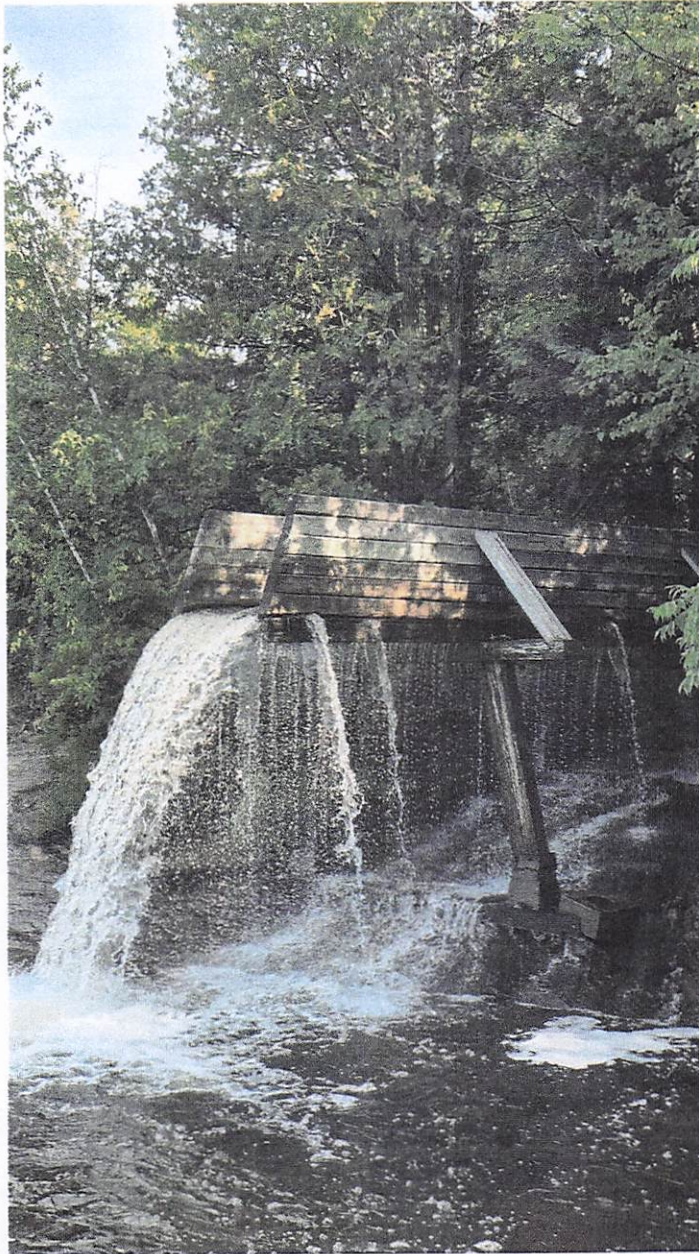
Photo #2: Lower Chute Outlet

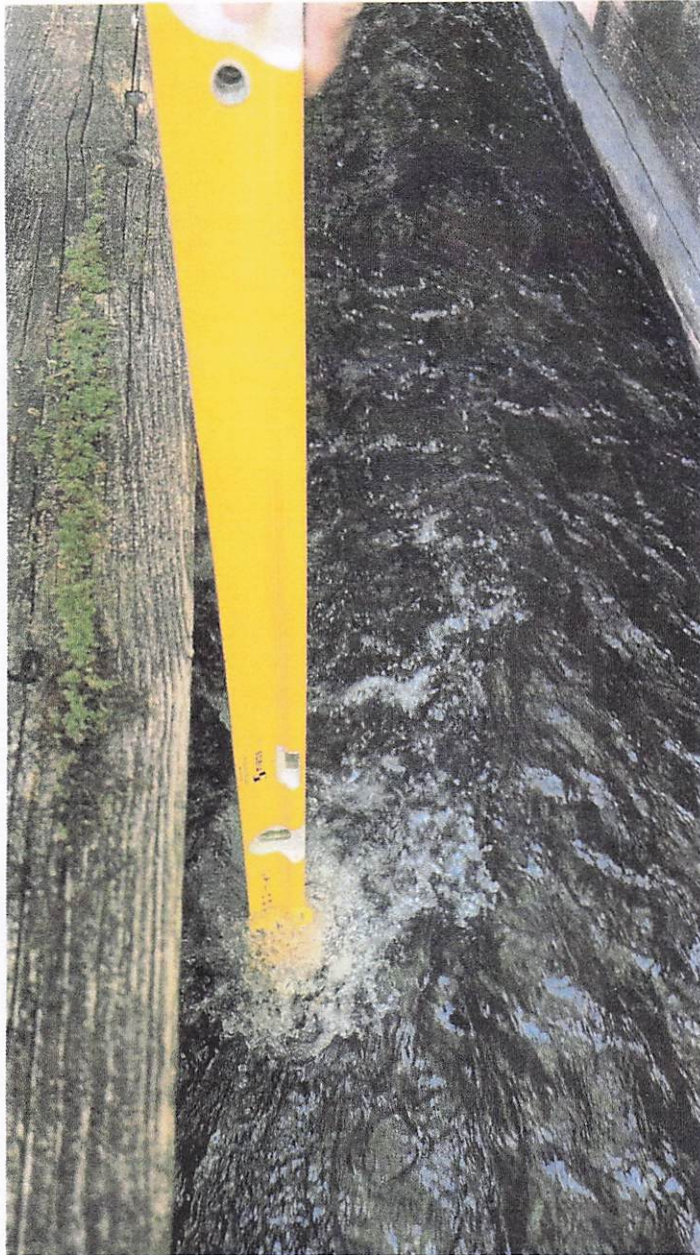
While not as significant as the lower elevated section of the log chute, the middle section of chute does show signs of deterioration that will need addressing in the shorter term. The mid-section runs for approximately 76 feet and is accompanied by a wooden walkway and guardrail described in the overview above. Once again, with the water flow present during inspections, it is hard to make an accurate assessment of the condition of the water deck. However, there is evidence of considerable water leakage at a number of points along this length of chute, suggesting sections of the water deck have failed. Additionally, this section shows signs of inward deflection of both sides of the chute (see photo #3). This is most likely caused by horizontal frost action over the years, forcing the sides inwards, coupled with the lack of any means of bracing or blocking that would counteract these forces. This inward sloping is more prevalent on the walkway side of the log chute. While it is not clear how long the sides have been in this condition or by what amount they worsen each year, the conditions at the time of inspection show a difference of on average 11" between the internal measurement taken at the bottom of the chute cross-section and the internal measurement taken at the top of the chute cross-section.

**Photo #3: Mid-Section Chute Inward Deflection**

Although the level of deterioration isn't as great in this section as the lower section of chute, the particular location of the deterioration still requires a complete disassembly of both the chute and the accompanying walkway and guardrails for proper repair. While the top three or four courses of 6" x 6" timbers in this section appear mostly intact and re-usable, they must be removed in order to get to the lower courses that do have significant decay. Moreover, the only means of correcting the inward deflection of the sides of the chute would be to completely disassemble the accompanying walkway and guardrail and excavating down to the base of the log chute. From here, the structurally deficient elements can be replaced, while also allowing the introduction of blocking/bracing at set intervals along the interior of the log chute (recommendation would be to install a 6" x 6" timber perpendicular to the sides and at the second or third course down from the top, every 8 feet). Removal and excavation of the walkway would also allow a form of retaining wall tie-backs to be introduced to the exterior of the walkway side of the log chute, and replacement of excavated material with better draining materials (crushed stone) to prevent horizontal frost heave in the future. It is estimated that 30% to 40% of the 6" x 6" timbers in this section are re-usable and it is once again advised that the re-usable members be used in the top most courses to allow for easier future replacement.

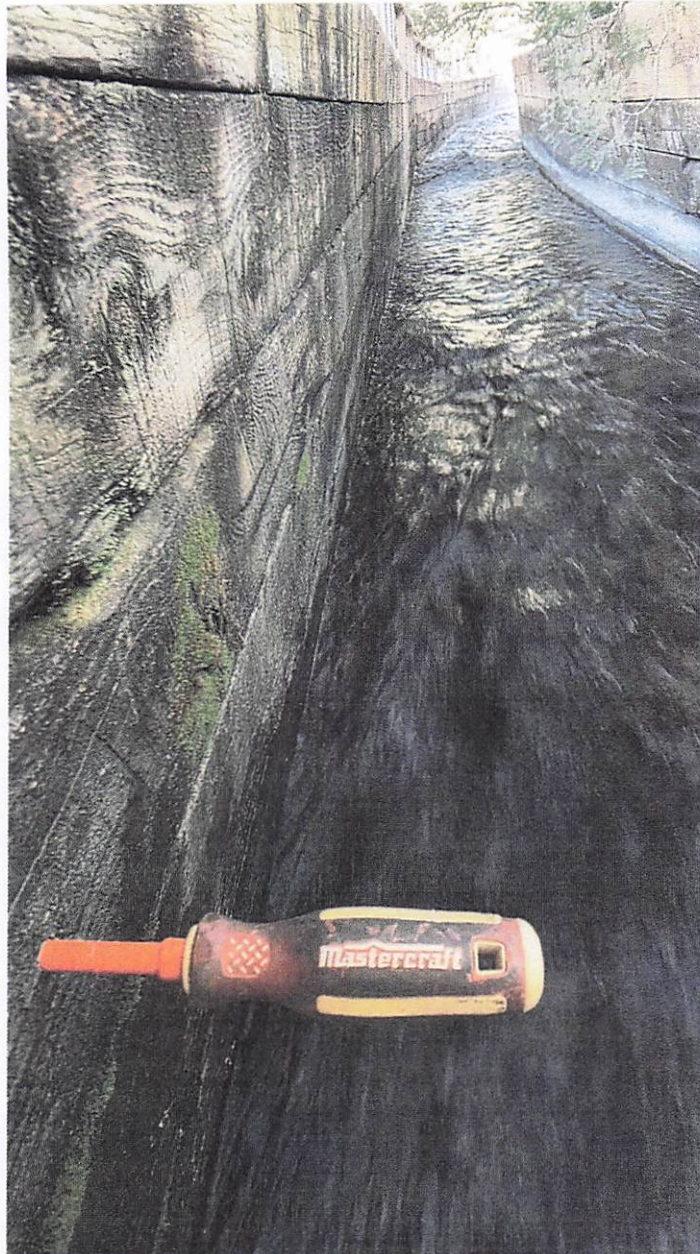
The mid-section is also showing significant signs of decay to the lower courses of 6" x 6" timbers. Using a screwdriver to test for approximate density of the material, we were able to penetrate the wood with ease on a number of timbers, particularly around the water line in the chute. Notably, the lowest course of timbers - just below the water line - was found to remain quite solid. However, all but the top 3 courses on either side of the chute exhibited serious deterioration and would require all courses to be removed for effective replacement (see

Photo #4: Mid-Section Chute 6" x 6" Timber Decay

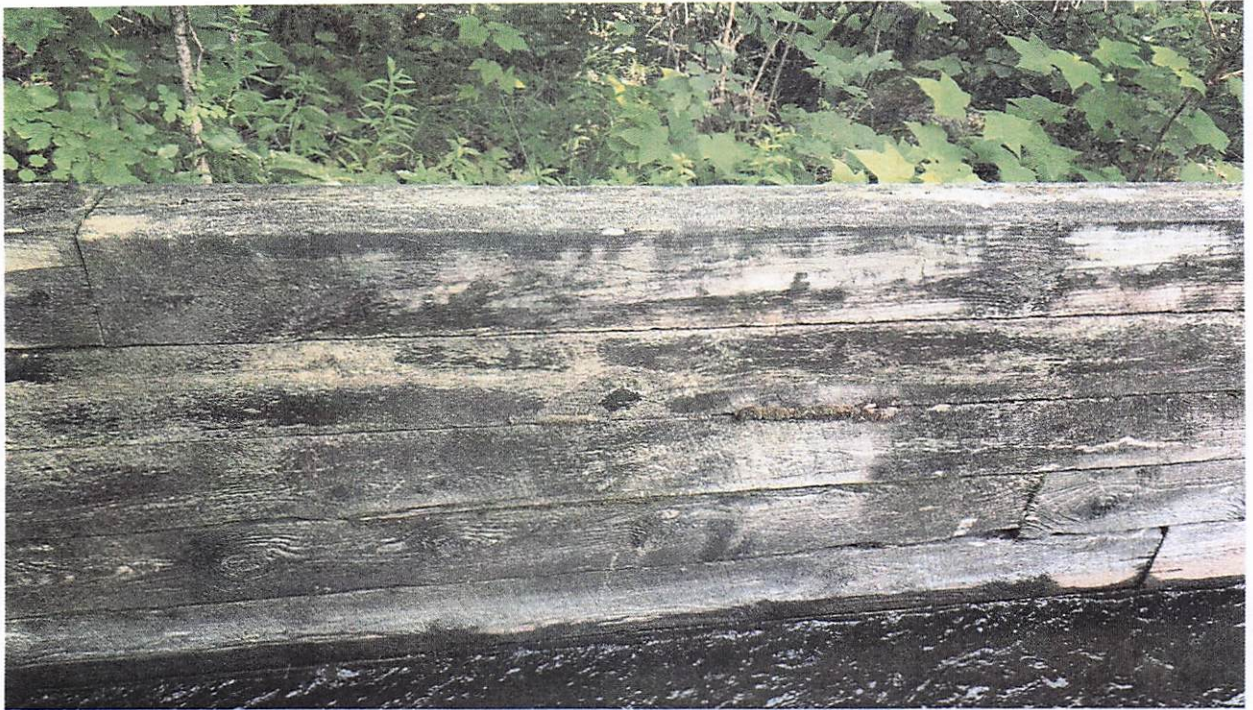
**Photo #5: Mid-Section Chute Decay**

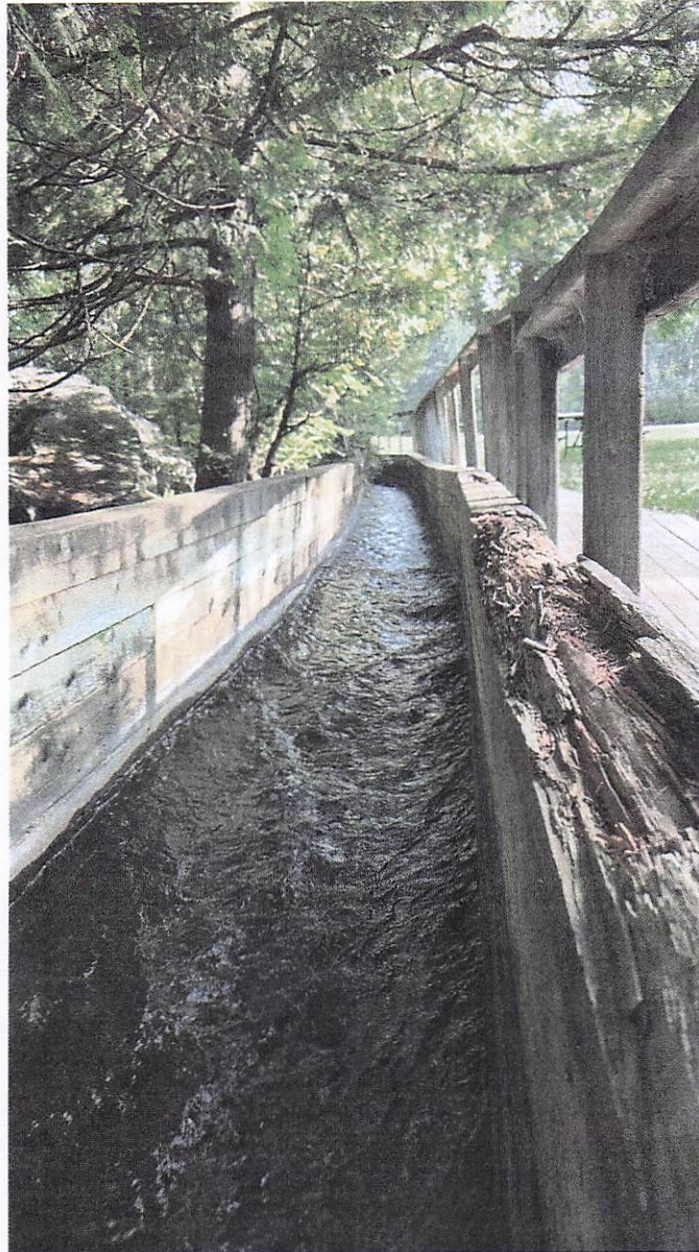
photos #4 and #5). There were a couple of instances here as well where a top timber had decayed on the surface with voids present (see photo #6).

Photo #6: Top Course Decay

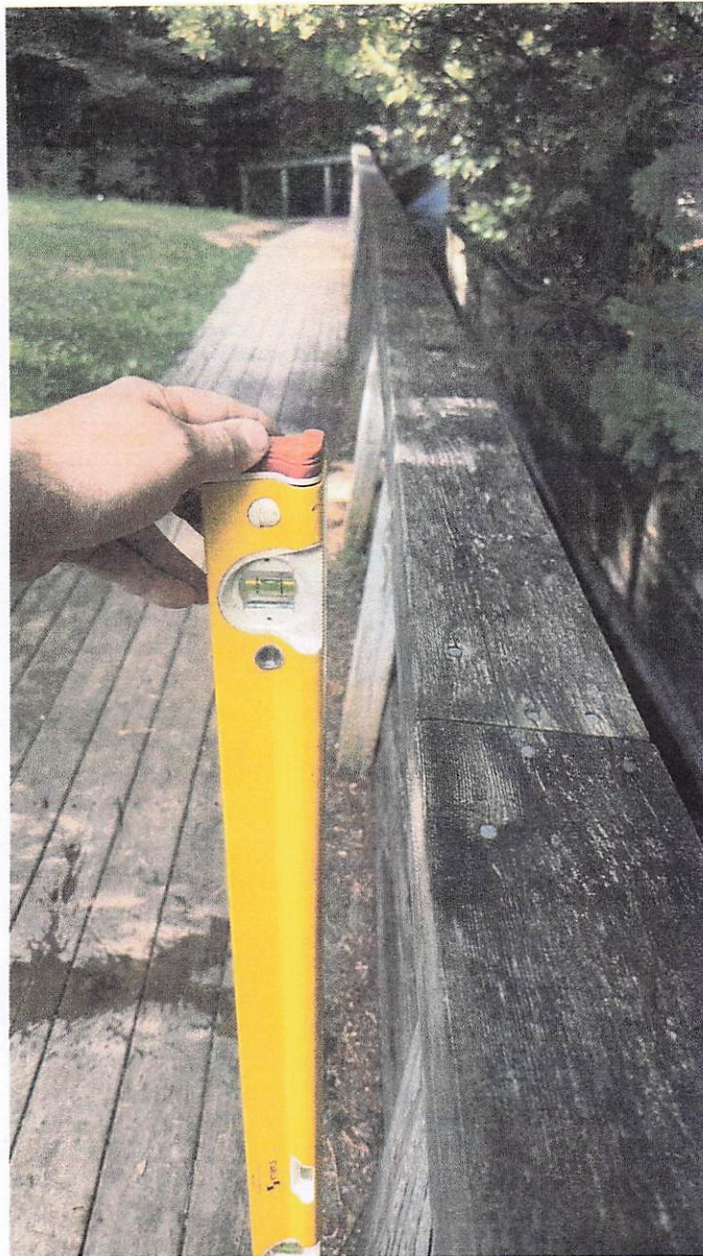
The accompanying wood walkway and guardrail in this section are showing normal signs of wear. The guardrail is largely solid with little to no sign of deterioration. However, it is being equally deflected by frost on account of its connection to the side of the log chute. The 4" x 4" posts run below the surface of the wooden decking and down the sides of the log chute. As a result, the guardrail assembly leans inward towards the chute (see photo #7). The walkway also has need of repair to a number of boards, and there are sections that feel quite spongy underfoot, suggesting a need to replace joists. While the walkway and guardrail in this mid section don't necessarily show major signs of deterioration, their removal and replacement may be necessitated by the greater need to repair significant parts of the log chute itself.

**Photo #7: Guardrail Deflection**

The above listed repair would again require the diversion of water at the chute's inlet and site fencing to close off the area of work. The recommended repairs also require the replacement of the removed wooden walkway and guardrail. These should be replaced to the same dimensions as existing. It is again advised that remedial works be carried out within the next two years to this section of the log chute.
