Township of Madawaska Valley

Road Flooding Risk

Final

November 27, 2025

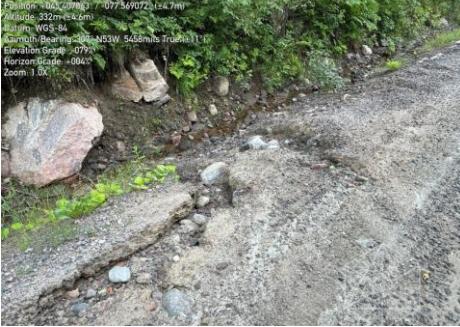
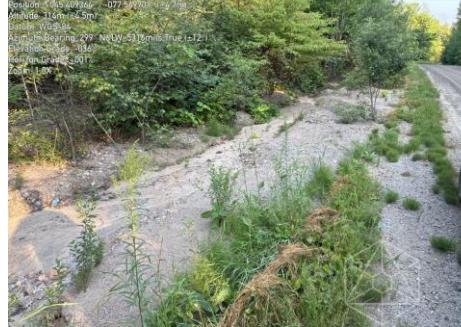
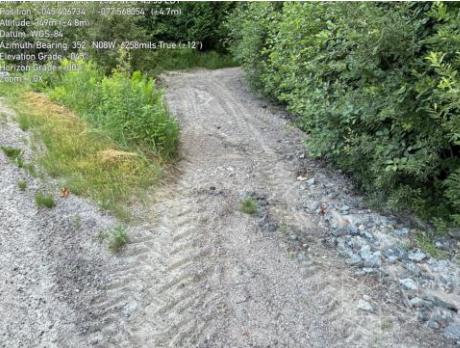
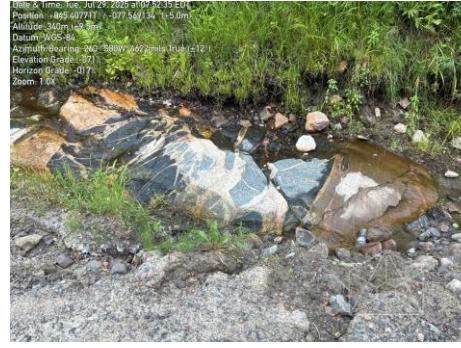
Location 1	Stanley Olsheski Road https://maps.app.goo.gl/j8JkRLJFHCbn8wy9
Description of Problem	The steep slope of the surrounding lands causes high water runoff velocity. The ditch has insufficient armouring to prevent scour issues, resulting in sediment moving.
Solutions	Make the east ditch larger and appropriately armoured with check dams.
Map

1. Stanley Olsheski Road - Make the north ditch larger and appropriately armoured with check dams.
2. Perrier Road - To prevent the diversion, the south ditch needs to be blocked to force water to go through the culvert. The south ditch also requires additional armouring with check dams. The culverts should be installed to direct the north ditch flows into the woods.
3. Lower Craigmont Road – No improvement works recommended.
4. Old Barrys Bay Road – Install larger culverts at two locations.

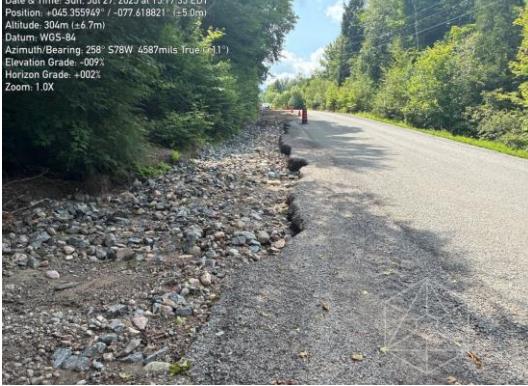
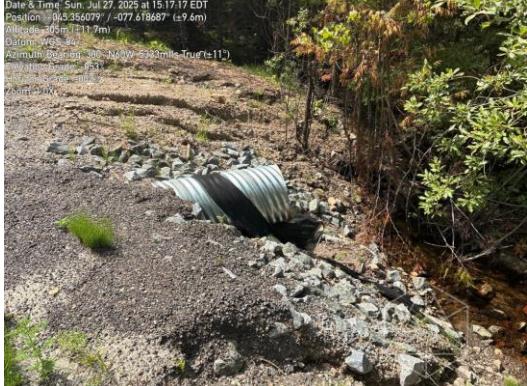
Location 2	<p>Perrier Road</p> <p>https://maps.app.goo.gl/ve5VxWxF44vrRyvR8</p>
Description of Problem	<p>Surcharging of the culvert causes road overtopping. The water bypasses the culvert (diverts down the ditch).</p> <p>The road crown elevation is not high enough to retain water within the culvert.</p>
Solutions	<p>To prevent diversion, the south ditch needs to be blocked to force water to flow through the culvert.</p> <p>The south ditch also required additional armouring with check dams. The culverts should be installed to direct the north ditch flows into the woods.</p>
Map

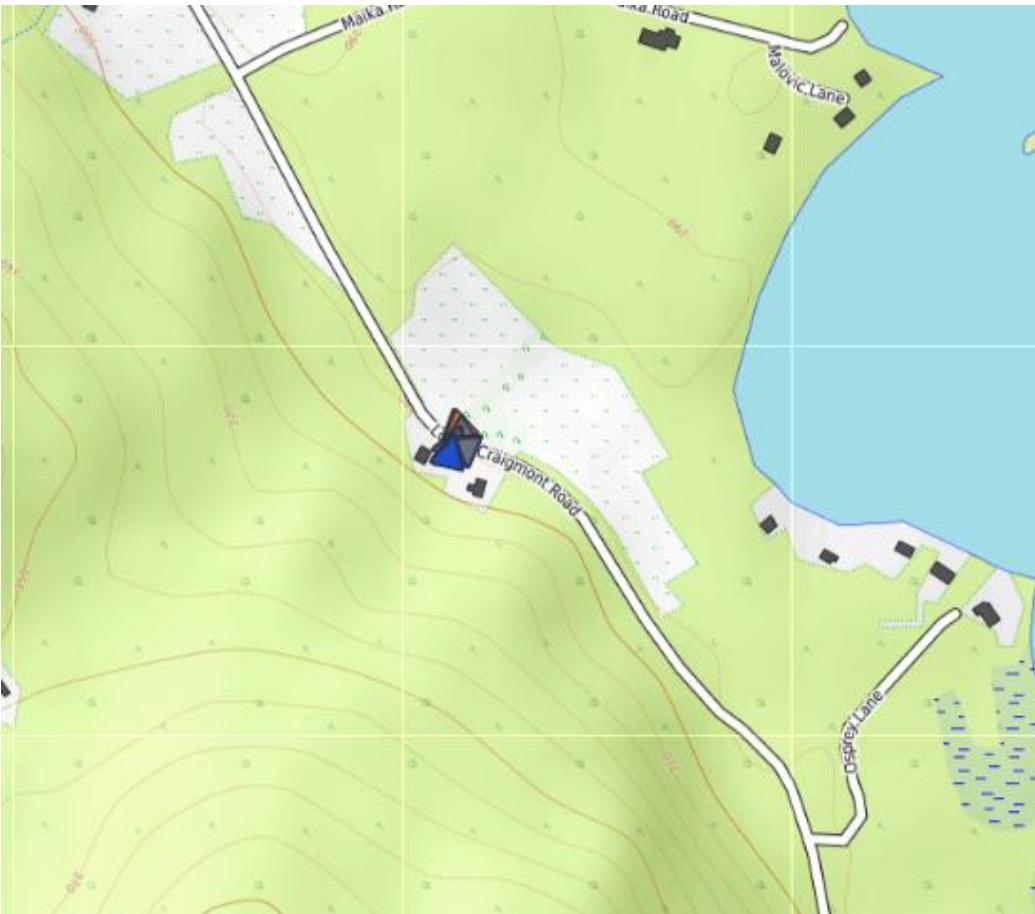
Location 3	<p>Lower Craigmont Road</p> <p>https://maps.app.goo.gl/KEYBkG5nNYpfsEDS8</p>
Description of Problem	<ul style="list-style-type: none"> The steep hill to the south and west of Lower Craigmont Road results in high water velocities during heavy precipitation events.
Solutions	<ul style="list-style-type: none"> Although there are debris and sediment flow concerns, the road did survive the 50-year flooding event. There is nothing that could be practically done by the Township to improve road resiliency.
Map

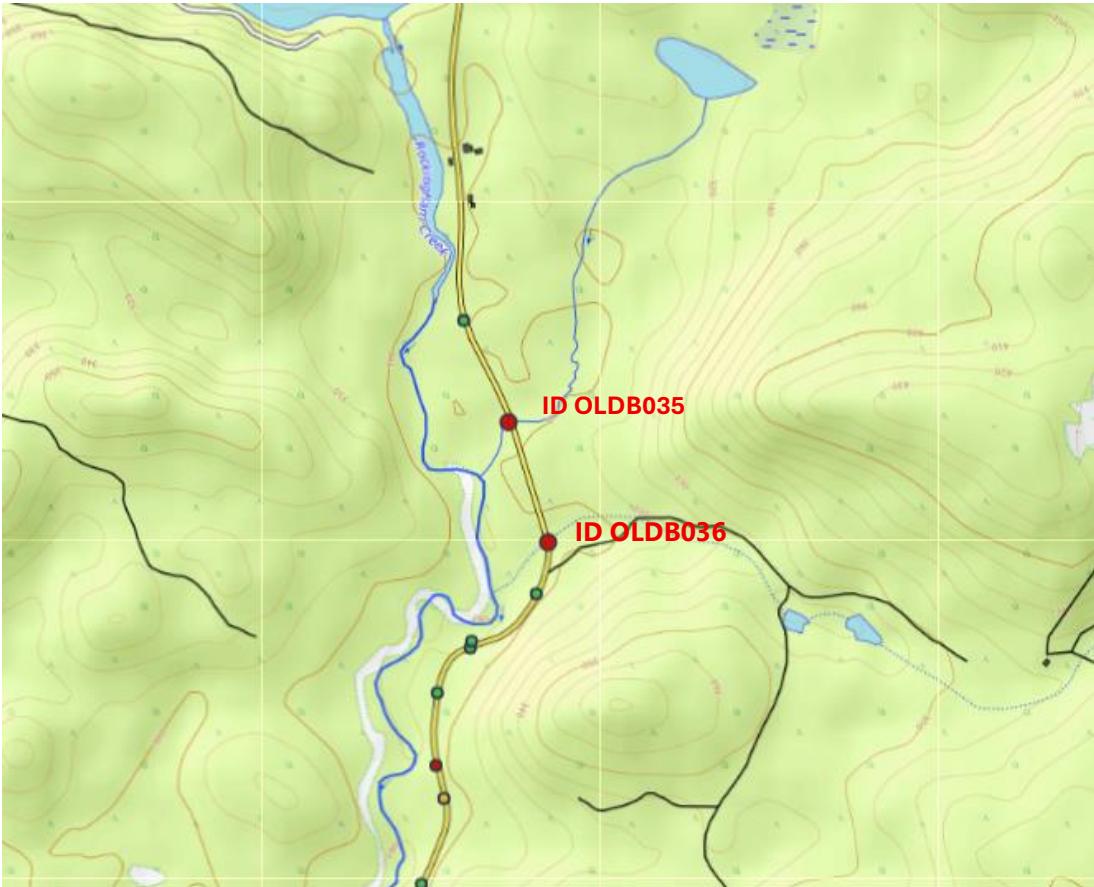
Location 4:	Old Barrys Bay Road https://maps.app.goo.gl/DN4FzWrqUwdBb9gv8
Description of Problem	<ul style="list-style-type: none"> Culverts ID OLDB035 and OLDB036 were calculated to have insufficient capacity. This likely contributed to the road overtopping, but as noted in the report, there was no damage to this section.
Solutions	<ul style="list-style-type: none"> The Township should install larger culverts at locations OLDB035 and OLDB036
Map

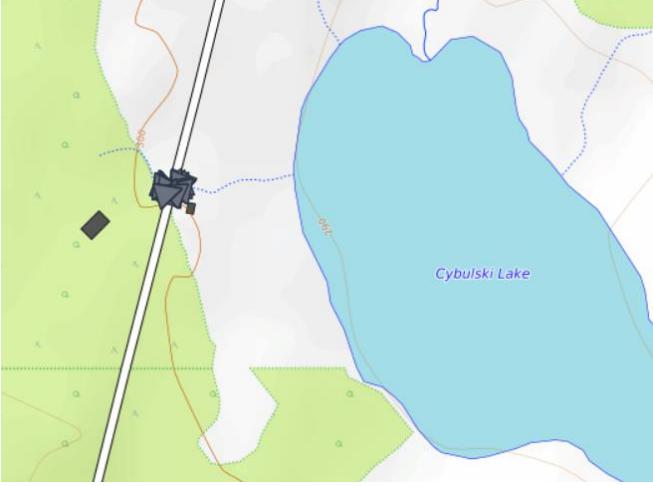
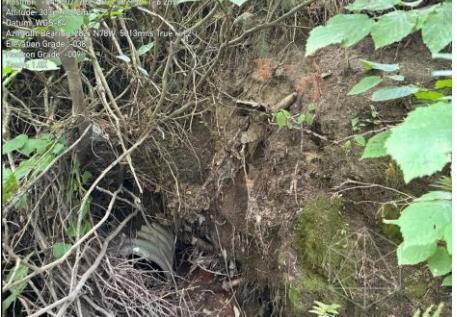
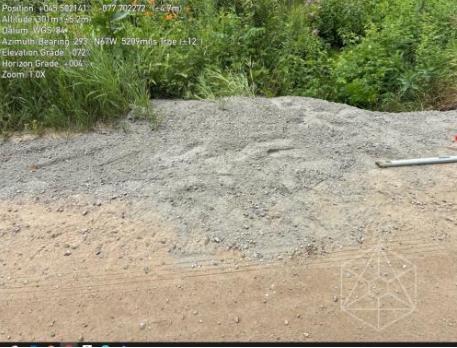
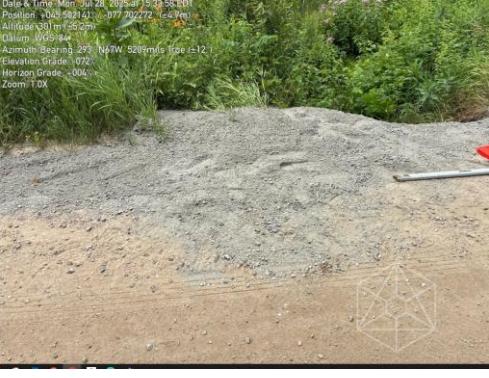
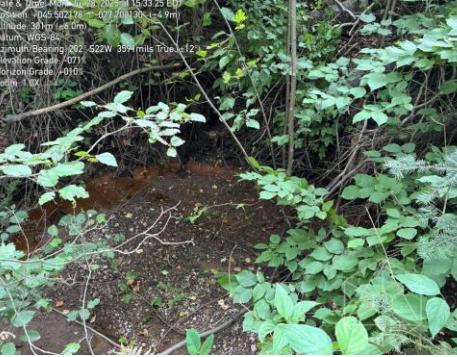
Location 5:	Martin Siding Road https://maps.app.goo.gl/OziT18eb3LUtbguT9		
Description of Problem	The culvert is not long enough and is too small. The roadside slope is too steep, resulting in unstable shoulder and sediment washout during overtopping events.		
Solutions	Install a longer and larger culvert, along with a wider road platform with a proper slope.		
Photo Map

5. Martin Siding Road - Install a longer and larger culvert, a wider road platform with proper slope.
6. Peplinski Road - Make the south ditch larger and better armoured with check dams.
7. Wilno Road North – Make the west ditch larger and better armoured with check dams.

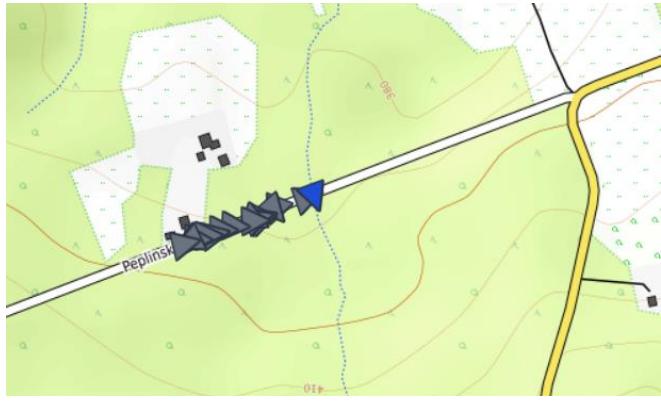
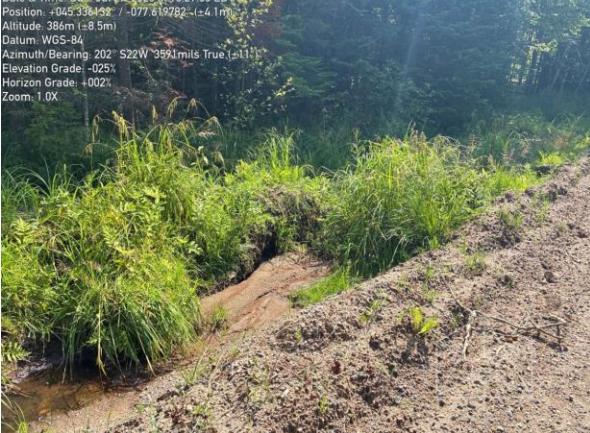
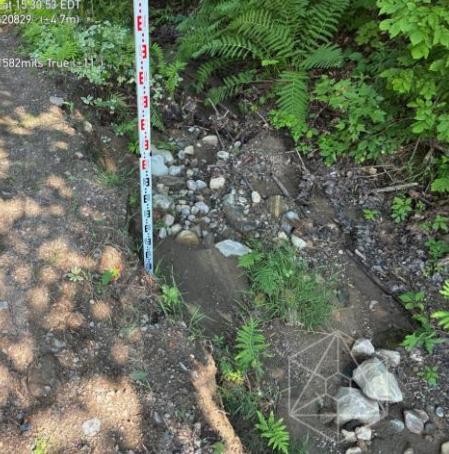
Location 6:	Peplinski Road https://maps.app.goo.gl/fpwuLVXuygxsFWY78
Description of Problem	The south ditch has naturally soft soils, which are not armoured enough.
Solutions	Larger and better armoured south ditch with check dams.
Photo Map

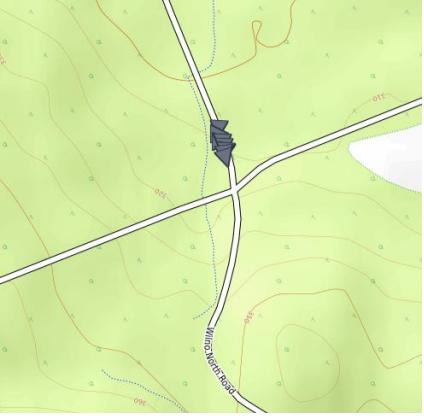
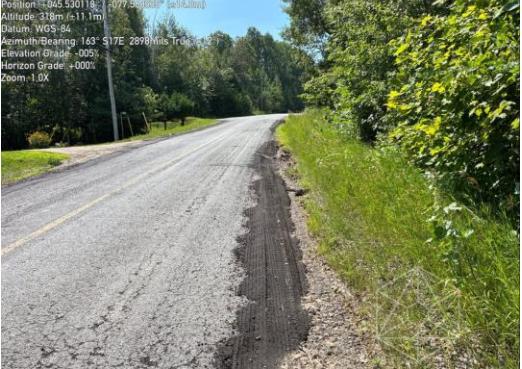
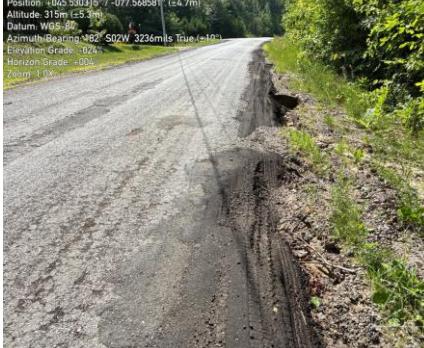
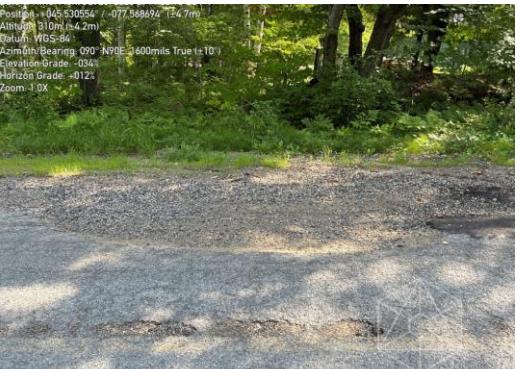
Location 7:	Wilno Road North https://maps.app.goo.gl/rzaej6sBfgBT4qKj6		
Description of Problem	West ditch is insufficient.		
Solutions	Larger and better armoured west ditch with check dams.		
Photo Map

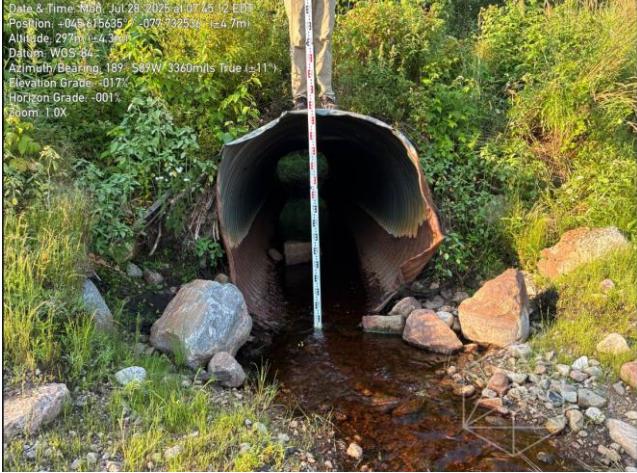
Location 1	
Asset ID	POTCREEK156
Location	https://maps.app.goo.gl/epvxaTcJwZTFyvp89
Comment	The culvert has failed.
Picture SQEX4646

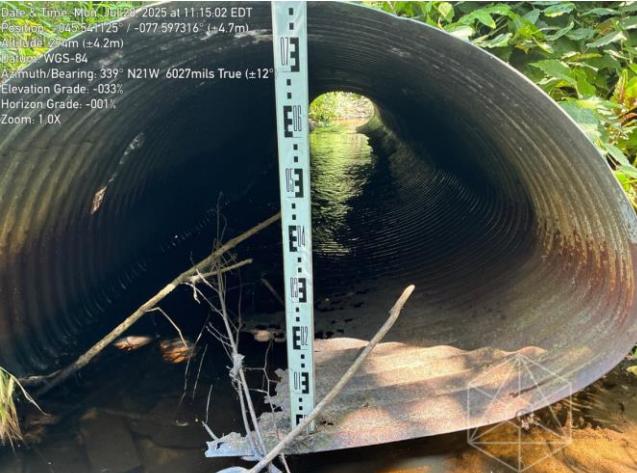
Location 2	
Asset ID	WIL3090
Location	https://maps.app.goo.gl/tuhd6AS4HnUQc7kF6
Comment	The culvert has failed.
Picture MSKE2667

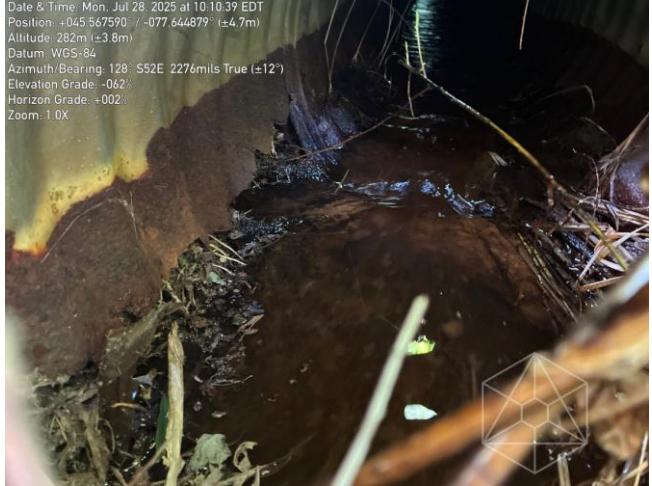
Location 3	
Asset ID	POTCREEK197
Location	https://maps.app.goo.gl/JgGhudCnbw5WSafW7
Comment	The culvert has failed.
Picture YEPH1410

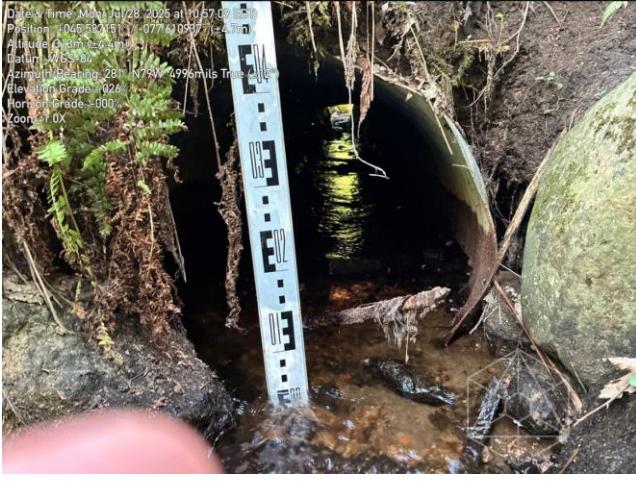
Location 4	
Asset ID	POTCREEK099
Location	https://maps.app.goo.gl/Sbj9jB1Pr4QdKQxR9
Comment	The culvert has failed.
Picture LJEE6986

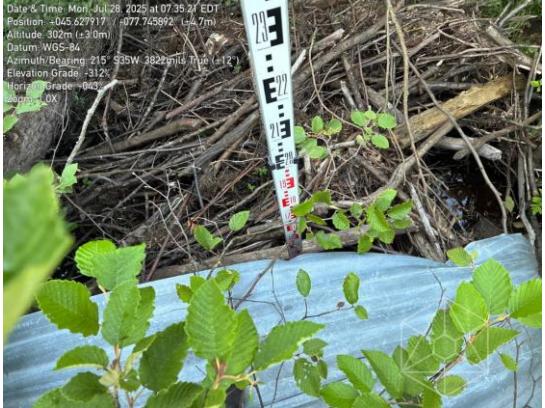
Location 5	
Asset ID	POTCREEK157
Location	https://maps.app.goo.gl/HXBMjVDYWfbkQ7hc6
Comment	Clearing and grubbing are required upstream of the culvert.
Picture FOAW1894

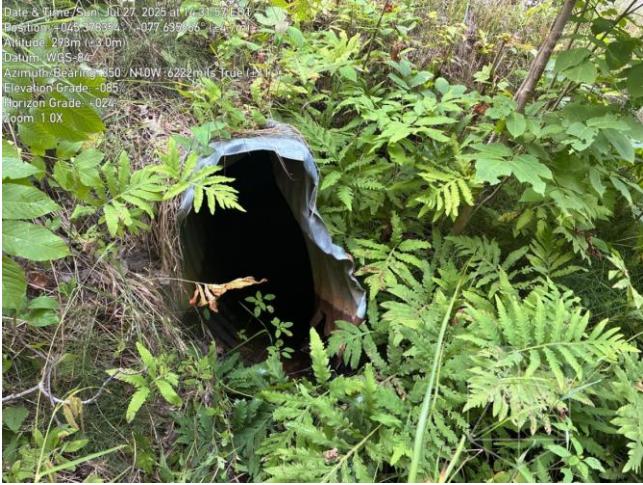
Location 6	
Asset ID	OHI08
Location	https://maps.app.goo.gl/pR1tjhUz6GTjGSvDA
Comment	The culvert has failed
Picture

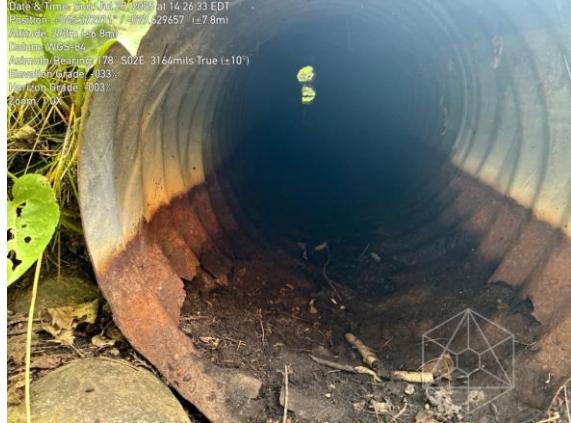
Location 7	
Asset ID	OHI06
Location	https://maps.app.goo.gl/RfsZssY94VUKybwI6
Comment	The culvert has failed.
Picture NPRJ1145

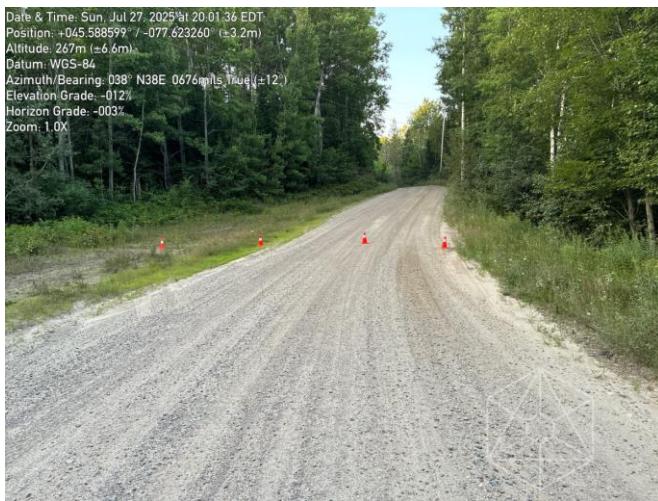
Location 8	
Asset ID	POTCREEK060
Location	https://maps.app.goo.gl/V8dSBB5obsaBjqE16
Comment	Needs a new culvert. There is currently no culvert, but a natural creek is washing over the road.
Picture FMNR3635
