REQUEST FOR TENDER
MV 2026-04
Barry's Bay Water Tower Repair

The Township of Madawaska Valley, herein known as the Township, is inviting submissions from qualified firms to complete repairs of the Barry's Bay Water Tower.

Cultural Heritage Assessment Report
CNR Water Tank
Barry's Bay, Township of Madawaska Valley,
Renfrew County, ON

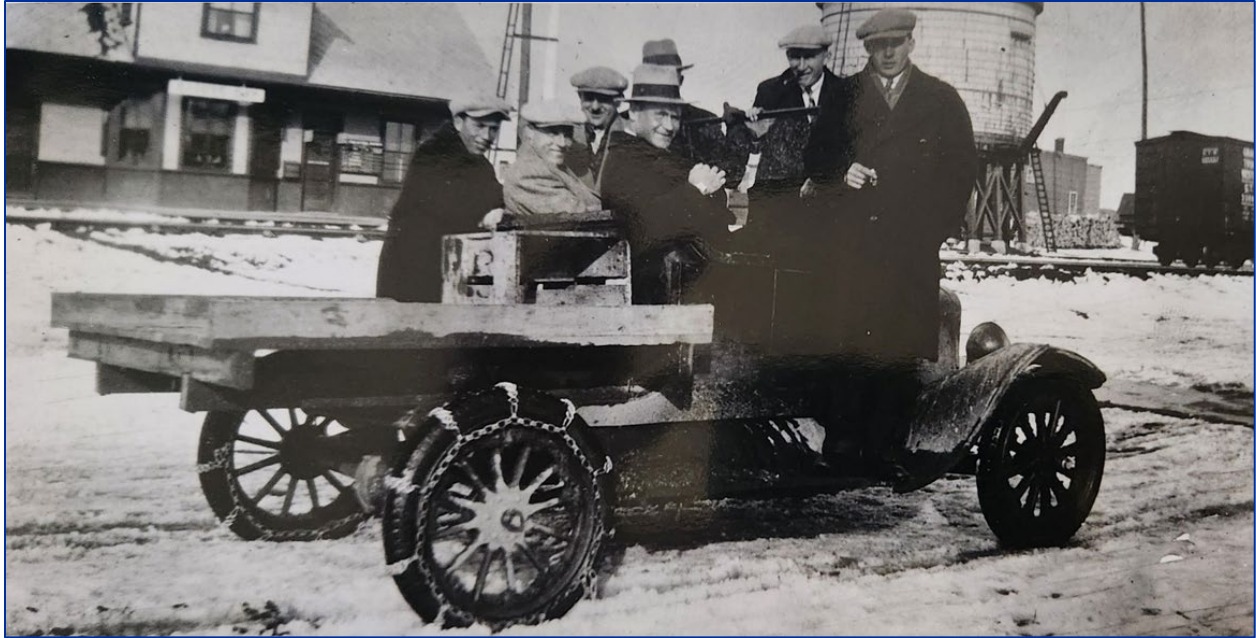
Image 4: View of the Station and the Water Tower at right, 1918-1923.⁵⁹

replaced the damaged wooden tub.⁵² A late 1910s photograph depicts the Water Tower with 21 iron hoops, a conical roof, a galvanized iron sway pipe spout, two access ladders, and a wooden timber frame on concrete piers (Image 4). The 1942 CNR Plan C-10161 illustrates the position of buildings and tracks including the location of the original Water Tower beside the Station. It notes that a 3-inch water main ran between the Water Tower and the Engine House adjacent to the wye formed by the two railway tracks (Figure 3).

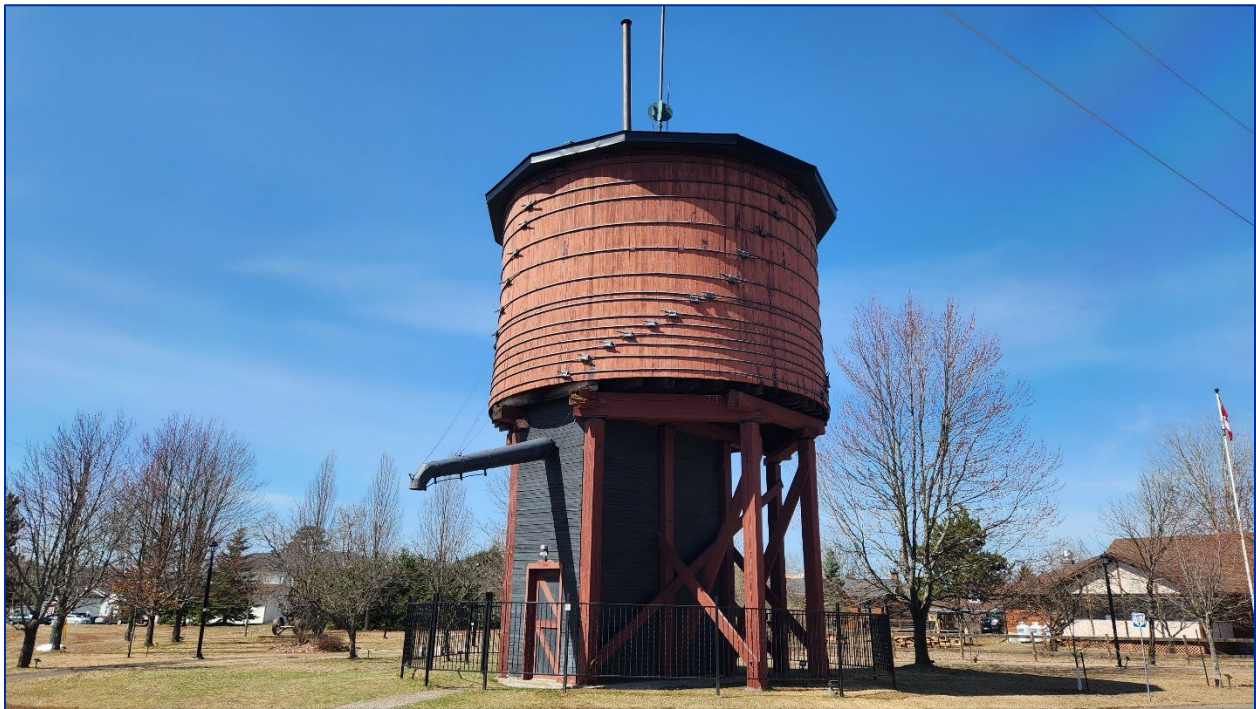
Photo 6: View of the Water Tower.

The water tower is a two-storey structure consisting of a round wood tank with a conical roof supported on a wood frame (Photo 6). A section of the area under the tank is enclosed –the frost box (Photo 6). The roof structure is wood-frame construction with laminated asphalt shingles, a metal float rod on the rooftop (Photo 7), a smokestack pipe, plywood boards, and a painted wood soffit at the perimeter of the roof. Access to the trap door at the rooftop is provided by a metal ladder which is installed on the exterior (Photo 8). Wood plank (2" x 6") siding with 14 malleable galvanized iron hoops fastened with iron lugs labelled "CNR-M" are installed on the exterior of the Water Tower (Photo 9).⁷⁰ The frost box structure is situated between the timber posts and clad in wood siding (Photo 10). The floor structure upon which the wooden tub sits, consists of wood joists (2.5" x 11") with wood plank deck. It is supported by 12 wood columns measuring (12" x 12") and beams in a cruciform plan on concrete piers—some of which are in deteriorated condition (Photo 11). A large metal sway pipe spout extends from the frost box structure (Photo 12). The frost box structure sits on a concrete slab surface which has voids (Photo 13).

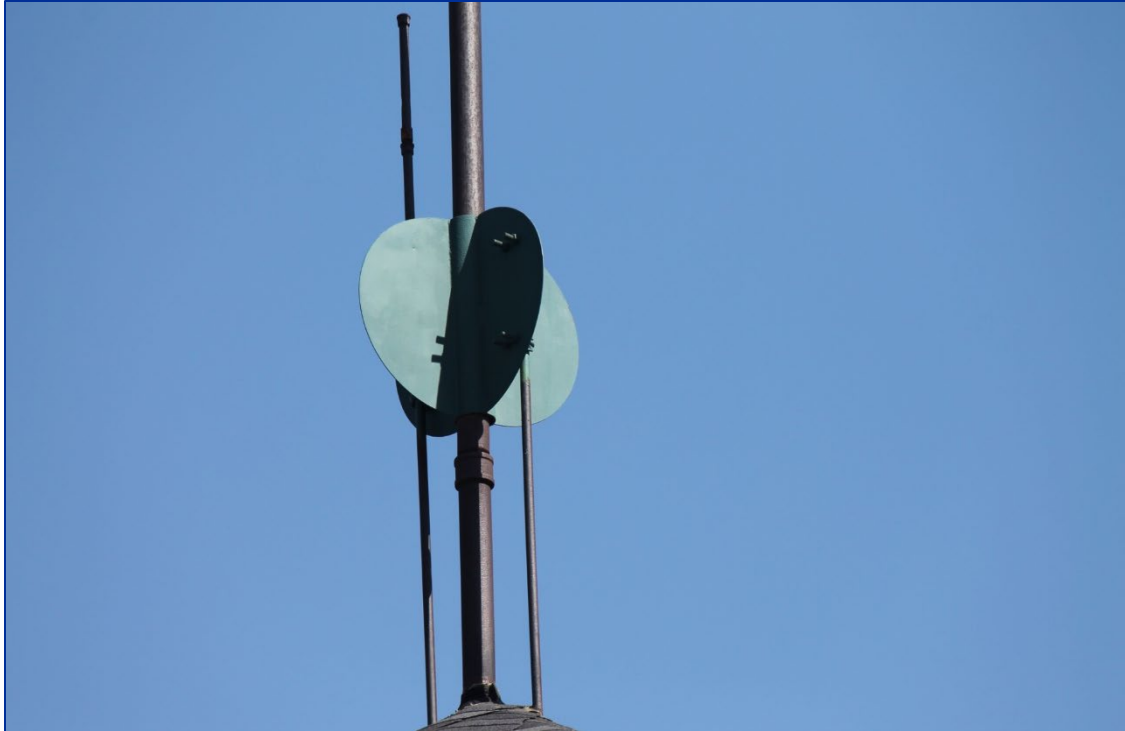
Photo 7: View of the metal float rod on the rooftop.

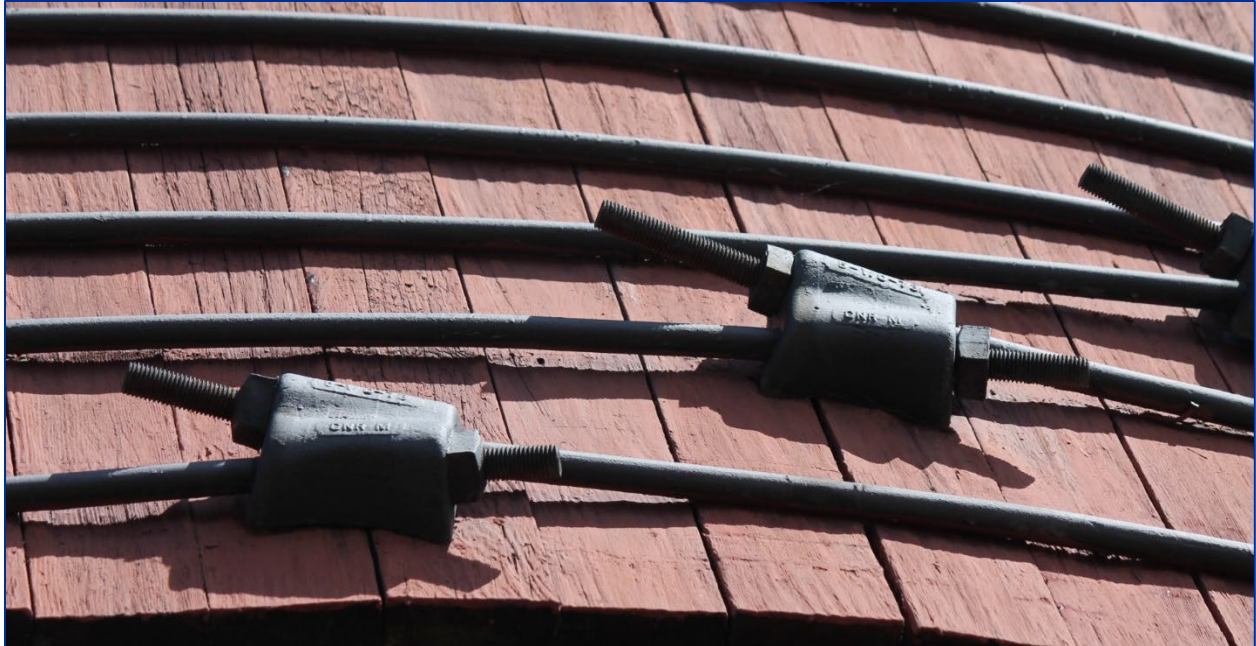
Photo 9: View of hoops and lugs marked "CNR-M".

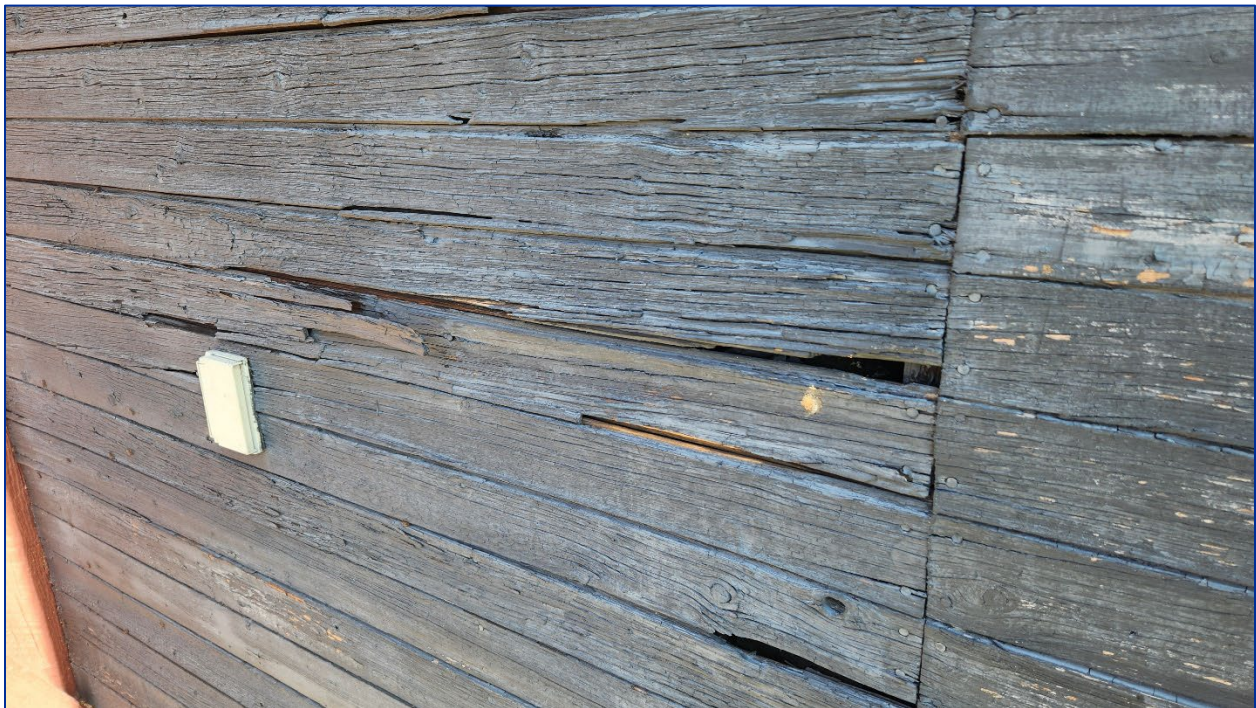
Photo 10: View of the wood siding of the frost box indicating horizontal checking damage.

- The frost box should be preserved with limited replacement (as needed) of deteriorated wood cladding.
- The timber structure supporting the Water Tank should be documented in detail and rehabilitated.

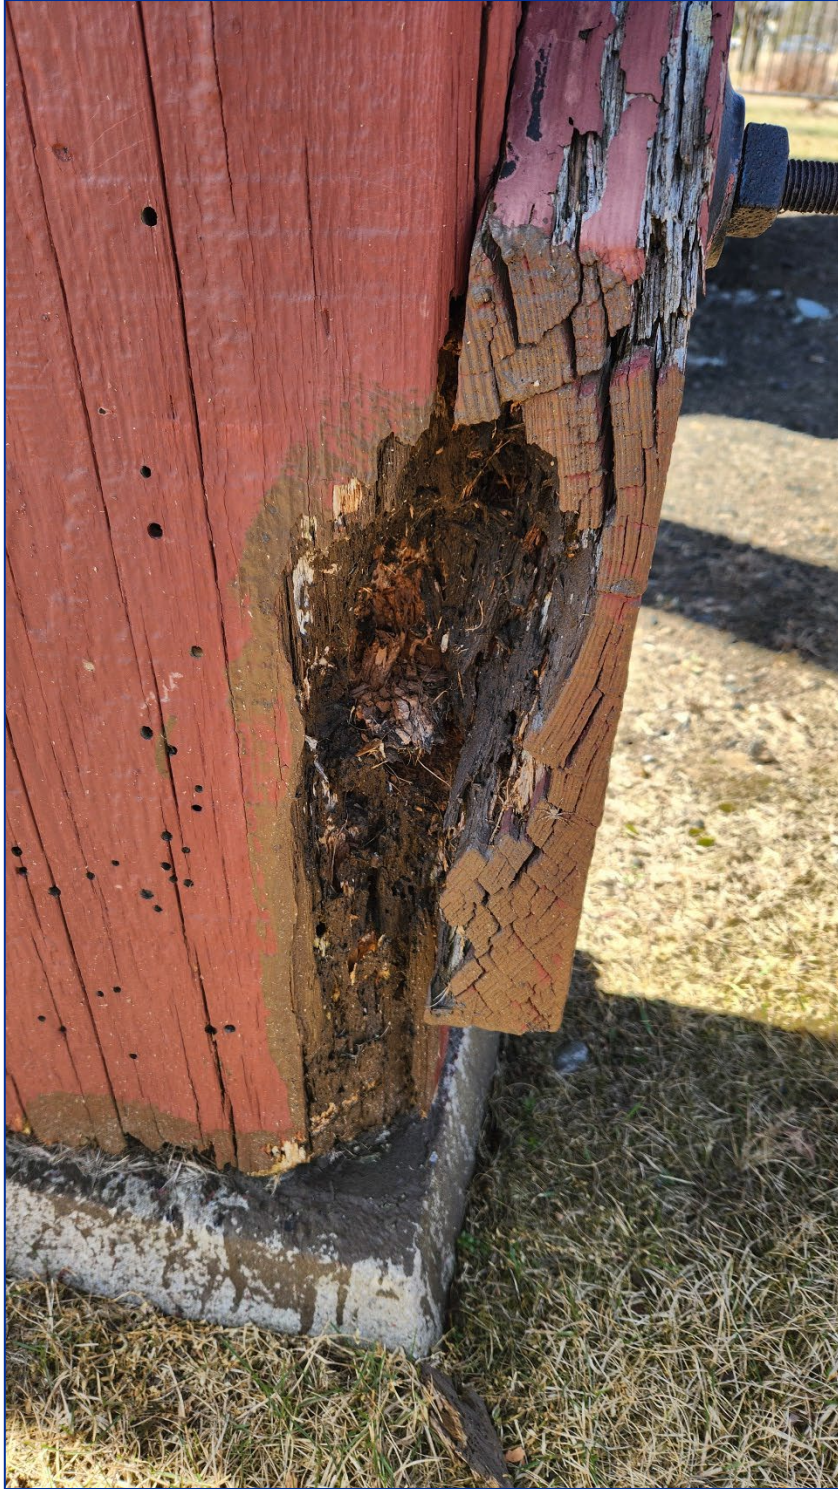
Photo 11: View of damaged and decaying wood timber supports.

- Replace structural timbers and bolts as needed.
- Address the void under the concrete slab and grading around the base of the Water Tower, including around the pier footings.

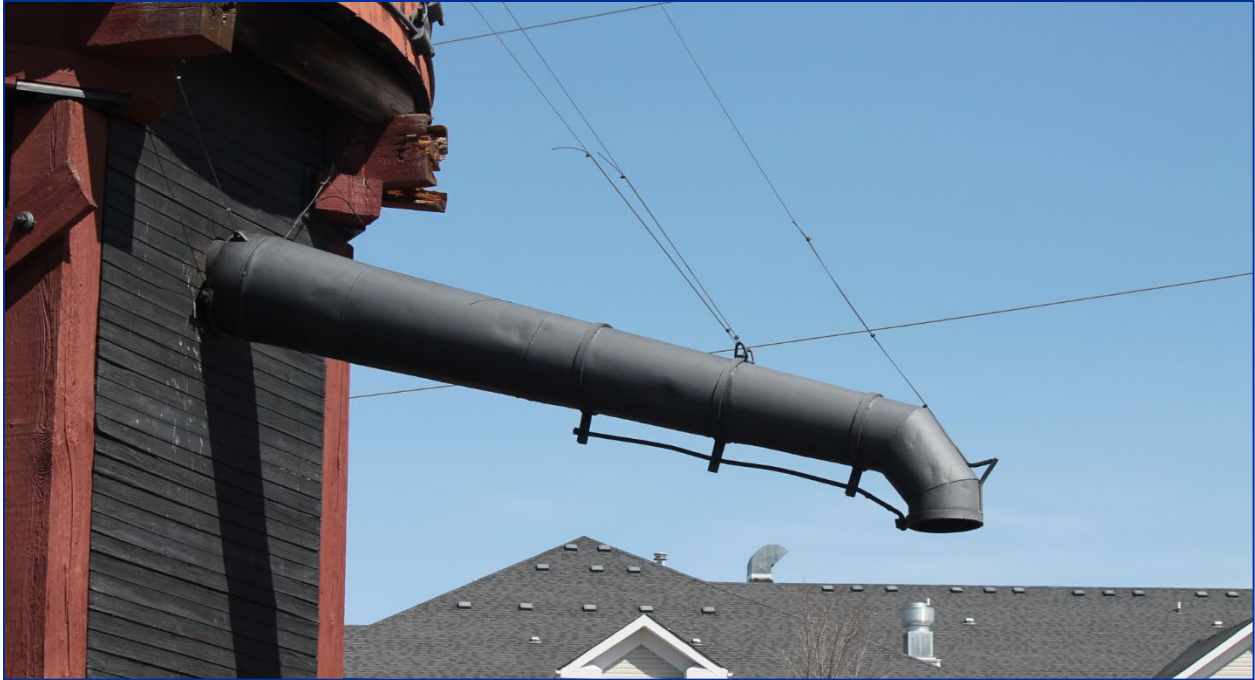
Photo 12: View of the metal spout.

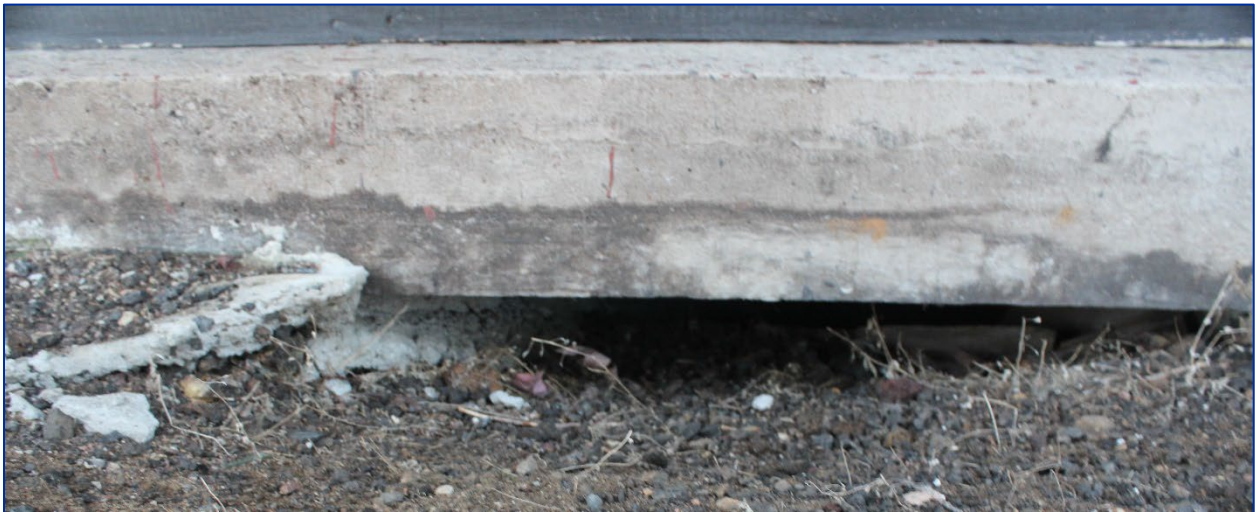
Photo 13: View of a void underneath the concrete slab foundation.

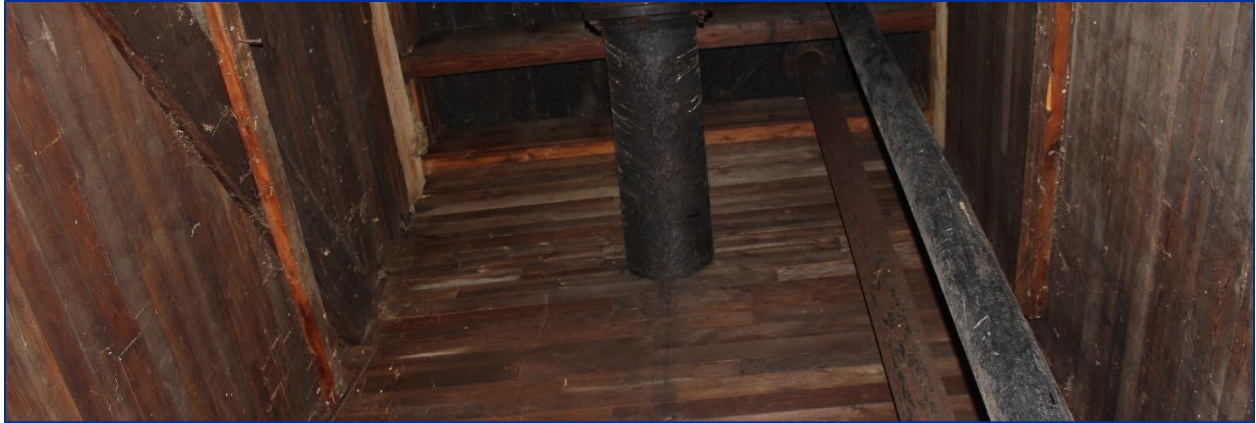
Photo 14: View looking up towards the ceiling with the wood siding and pipe remnants visible.

The interior frost box of the Water Tower is accessed through a wooden door. It is a rectangular space with pipes. The walls are clad in horizontal wood siding (Photo 14 and Photo 15). It contains the remnants of large metal pipes and a T. McAvity & Sons valve (Photo 16).

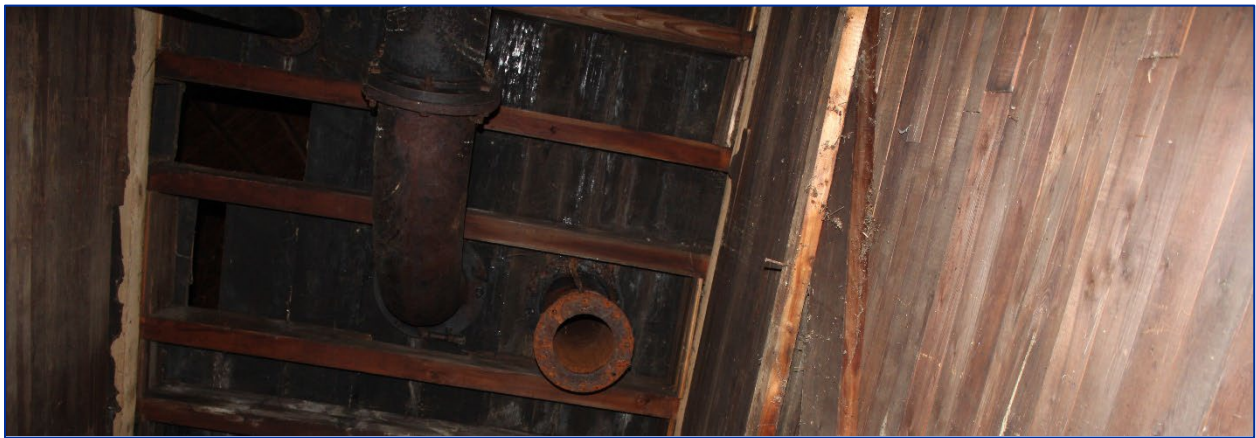
Photo 15: View looking up towards the ceiling with pipe remnants visible.

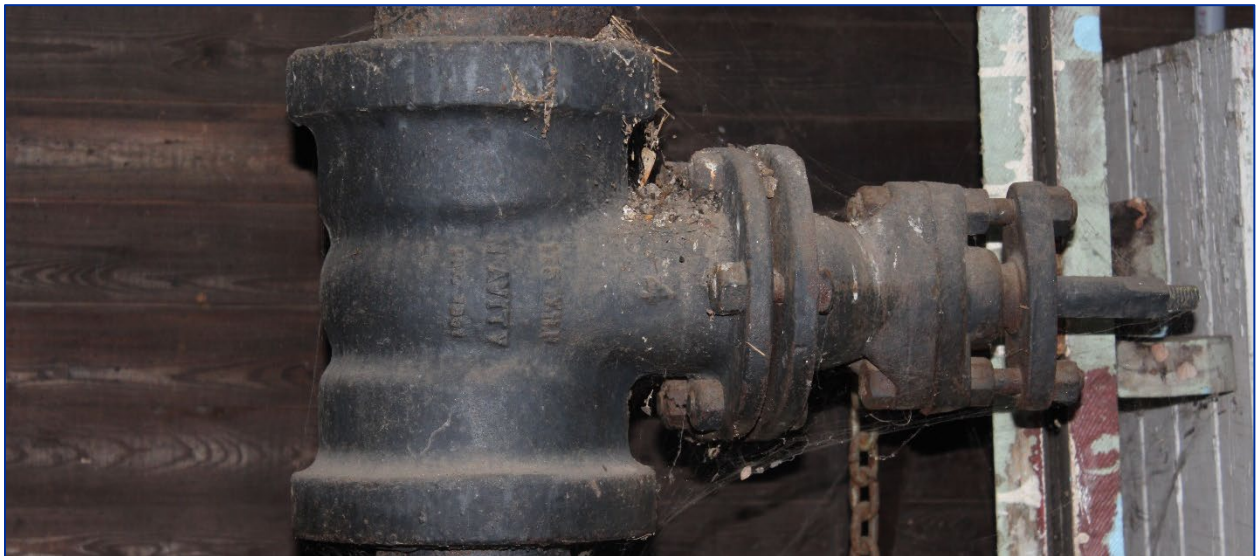
Photo 16: View of a McAvity 175 W.H.P. valve remnant.
