Township of Madawaska Valley

Road Flooding Risk

Final

November 27, 2025

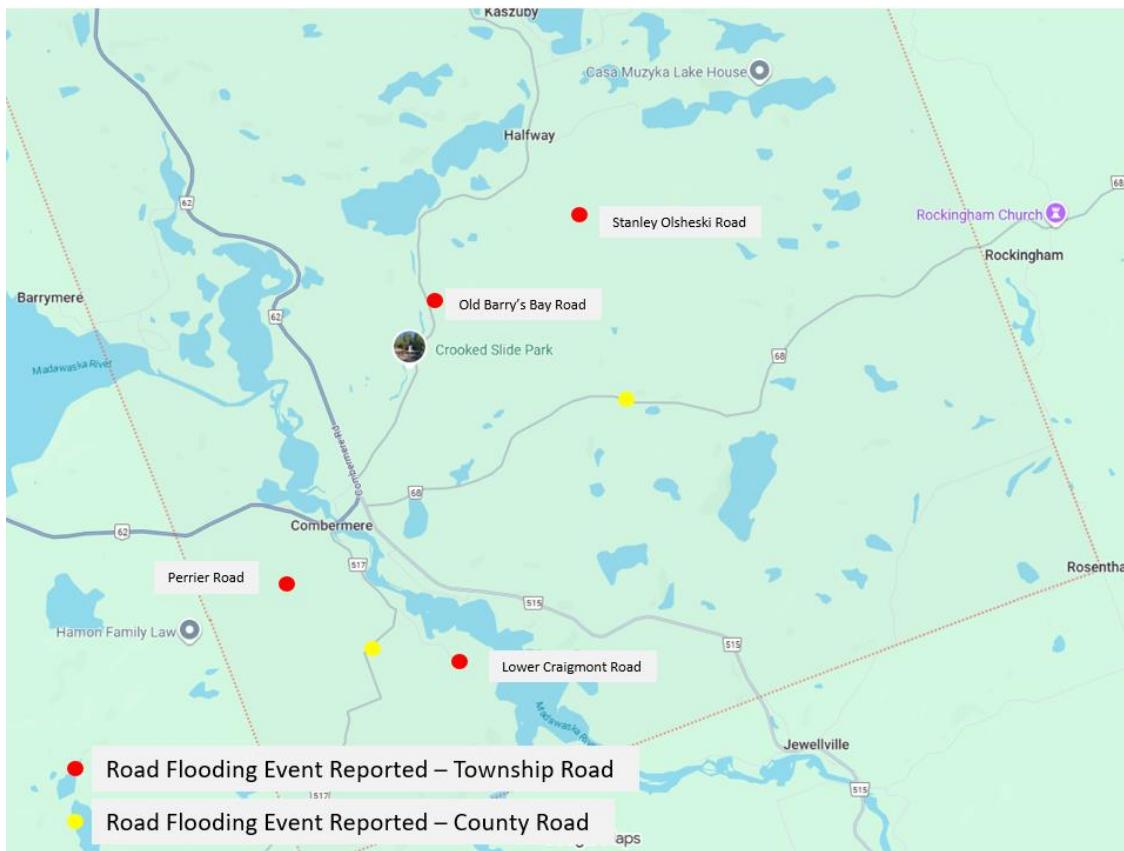
Figure 1 – Locations of Road Flooding on August 18, 2024

- At 1 pm, the Township received reports of flooding on Lower Craigmont Road near Combermere. At 1:30 pm, staff observed water 150 mm to 200 mm deep flowing down the adjacent hillside, overwhelming culverts and ditches
- By 2:45 pm, a resident reported a washout on Perrier Road. Township staff arrived to at 2:53 to observe that half of the roadway had completely washed out and collapsed
- At 3:22 pm, Township staff were contacted by Renfrew County staff who indicated two County roads in the Township (Rockingham Road and Dafoe Rao) were also washed out.
- At 3:34, Township staff observed 200 mm of water flowing over Old Barry's Bay Road.
- At 4:08 pm, staff received a call that Stanley Olsheski Road was washed out entirely.

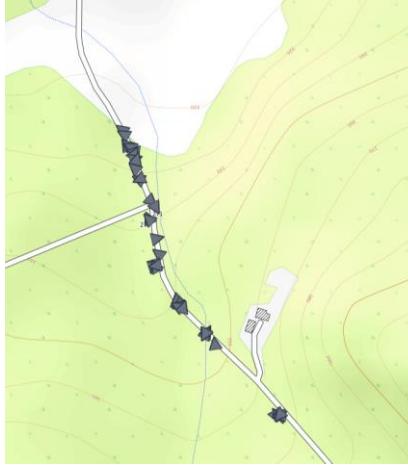
Location 1	Stanley Olsheski Road https://maps.app.goo.gl/j8JkRLJFHCbn8wy9
Description of Problem	The steep slope of the surrounding lands causes high water runoff velocity. The ditch has insufficient armouring to prevent scour issues, resulting in sediment moving.
Solutions	Make the east ditch larger and appropriately armoured with check dams.
Map

1. Stanley Olsheski Road - Make the north ditch larger and appropriately armoured with check dams.
2. Perrier Road - To prevent the diversion, the south ditch needs to be blocked to force water to go through the culvert. The south ditch also requires additional armouring with check dams. The culverts should be installed to direct the north ditch flows into the woods.
3. Lower Craigmont Road – No improvement works recommended.
4. Old Barrys Bay Road – Install larger culverts at two locations.

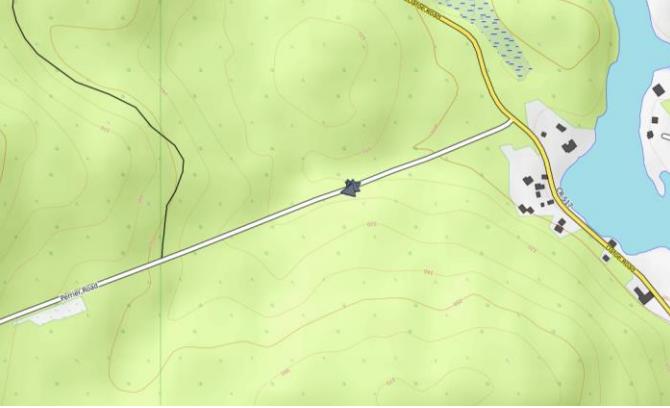
Location 2	<p>Perrier Road</p> <p>https://maps.app.goo.gl/ve5VxWxF44vrRyvR8</p>
Description of Problem	<p>Surcharging of the culvert causes road overtopping. The water bypasses the culvert (diverts down the ditch).</p> <p>The road crown elevation is not high enough to retain water within the culvert.</p>
Solutions	<p>To prevent diversion, the south ditch needs to be blocked to force water to flow through the culvert.</p> <p>The south ditch also required additional armouring with check dams. The culverts should be installed to direct the north ditch flows into the woods.</p>
Map
